# Long Meg and her Daughters

## Geology and condition survey, May 2023

### Condition report and recommendations

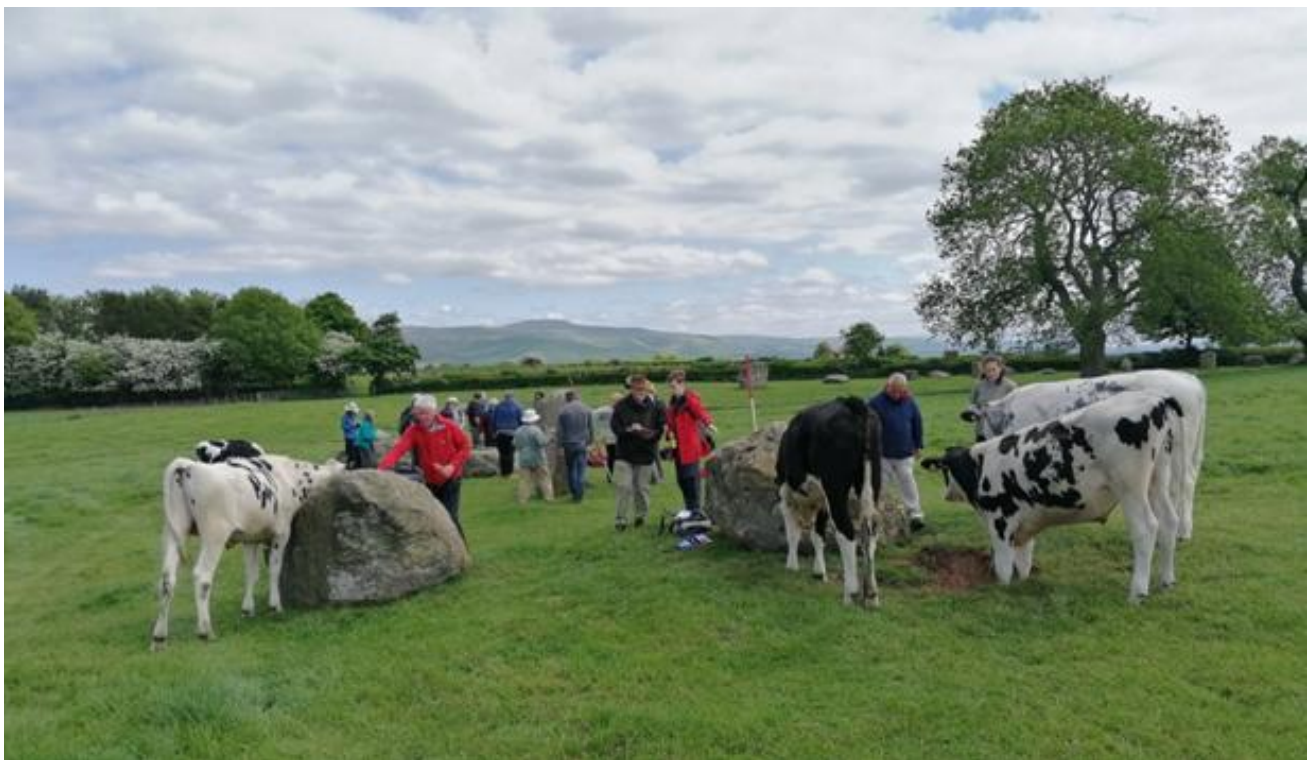
**Cover image.** Volunteers at work on the geology and condition survey of Long Meg stone circle, May 2023. Note the beast to the bottom-right, with its front legs firmly planted within the erosion hollow to the west of Stone 18.

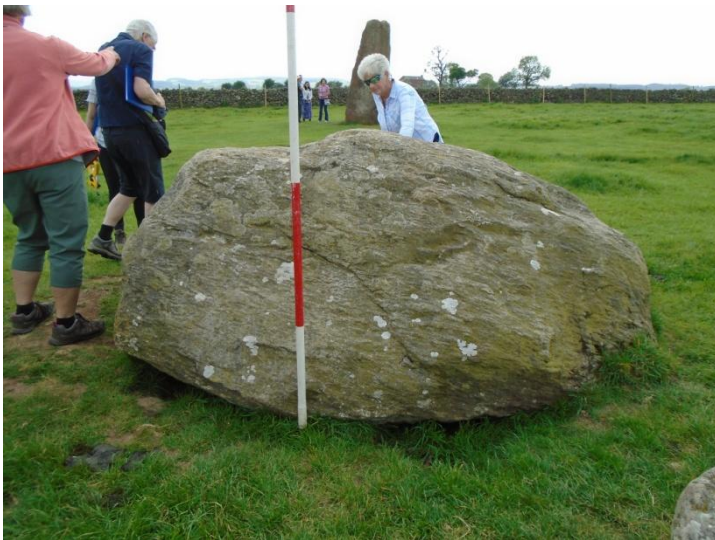
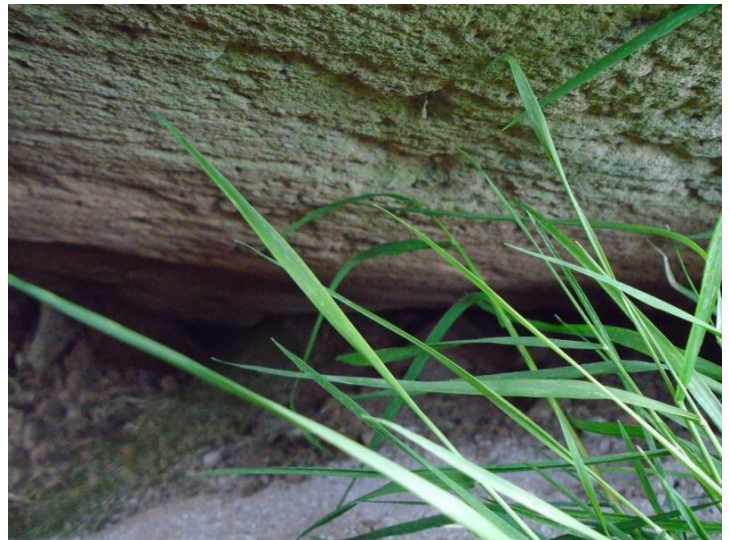
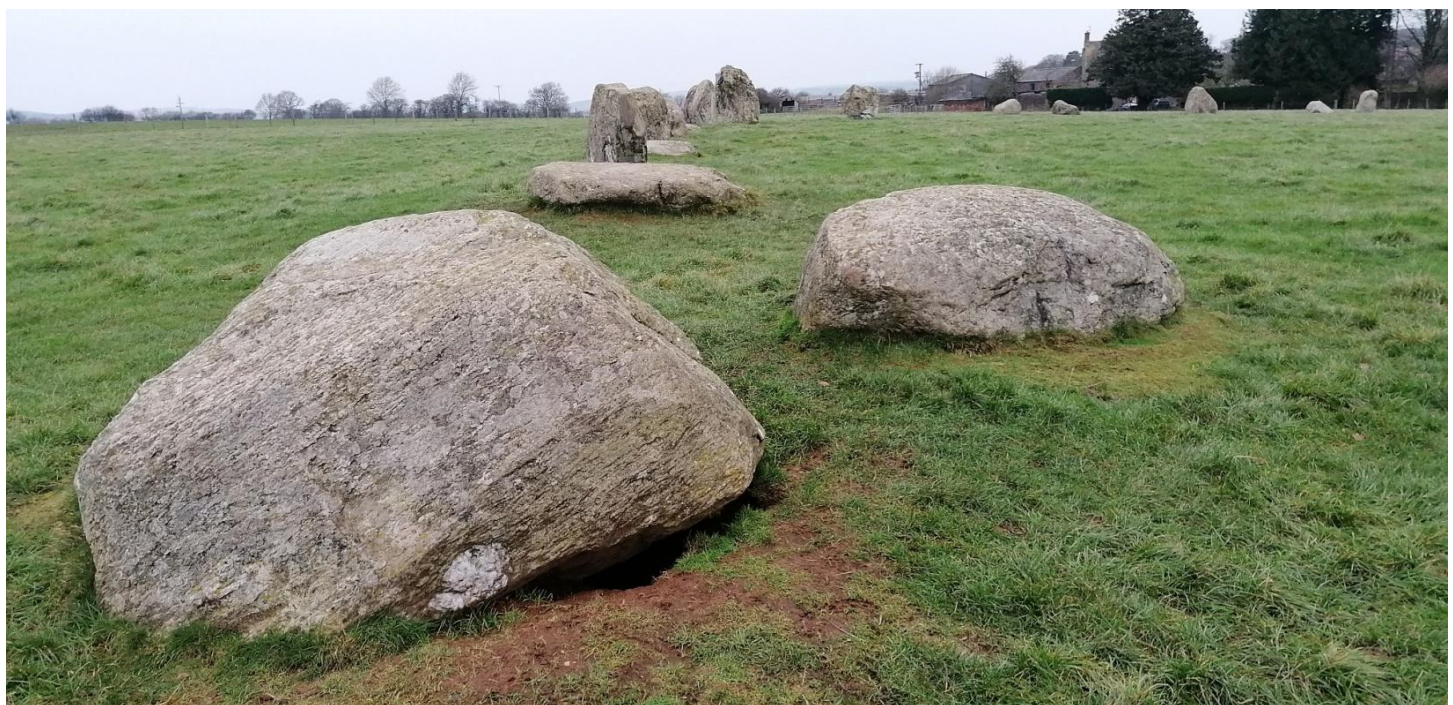
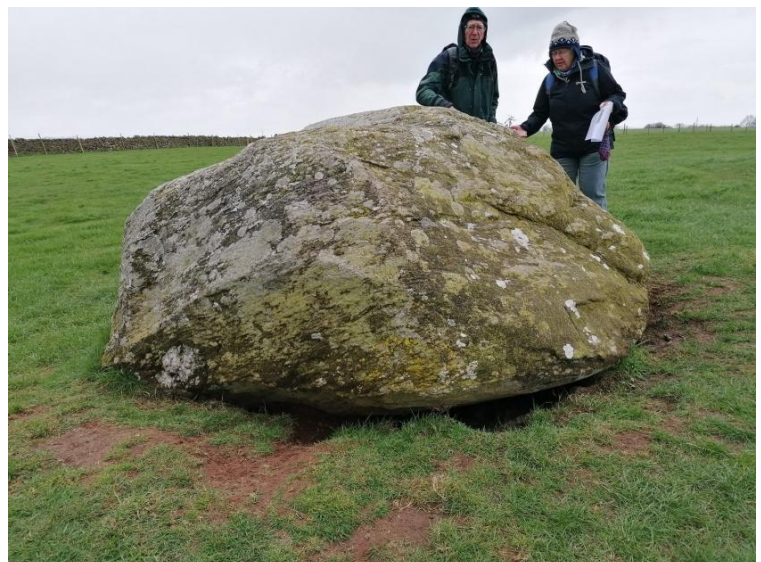
## Stone 2

Stone 2 is a very large BVG boulder measuring 290 x 260cm. It is presumed to have stood upright and to have fallen south-westwards onto its inner face; its current height above the turf is 120cm. It forms the western outer portal of the circle's supposed south-west entrance, opposite the eastern outer portal that still stands. The eastern portal has its flat face facing

across the entrance; the buried face of the Stone 2, where exposed by rabbit burrowing, appears to have a similarly flat face. Stone 2 has a large quartz nodule in what would have been its upper surface when erect; nothing like this has been noted on any other stones and its presence here cannot be by chance. Stone 2 is the closest daughter to long Meg, and lies on the circle's crucial winter solstice sunset alignment. Stone 2 is therefore a very important stone, and the extent of rabbit burrowing beneath it is of very great concern.

*Top left: General view from the SE showing burrowing beneath the stone.*

*Top right: Close-up, showing flat buried face of stone and burrowing beneath.*

*Centre: A view taken in December 2021, with damage clear due to low grass cover.*

*Right: A view from the E taken in April 2023, showing damage extending around the stone.*

Excavating beneath large stones such as Stone 2 is clearly impractical, and moving these stones to enable investigation beneath them would also be far from straightforward. It may be that the best that can be done here is to record the damage as accurately as possible and backfill the hollows. In contrast, working around some of the other stones would be much more feasible; some could perhaps be carefully dragged out of position to enable excavation beneath them, as long as they were replaced in their exact positions on completion of work.

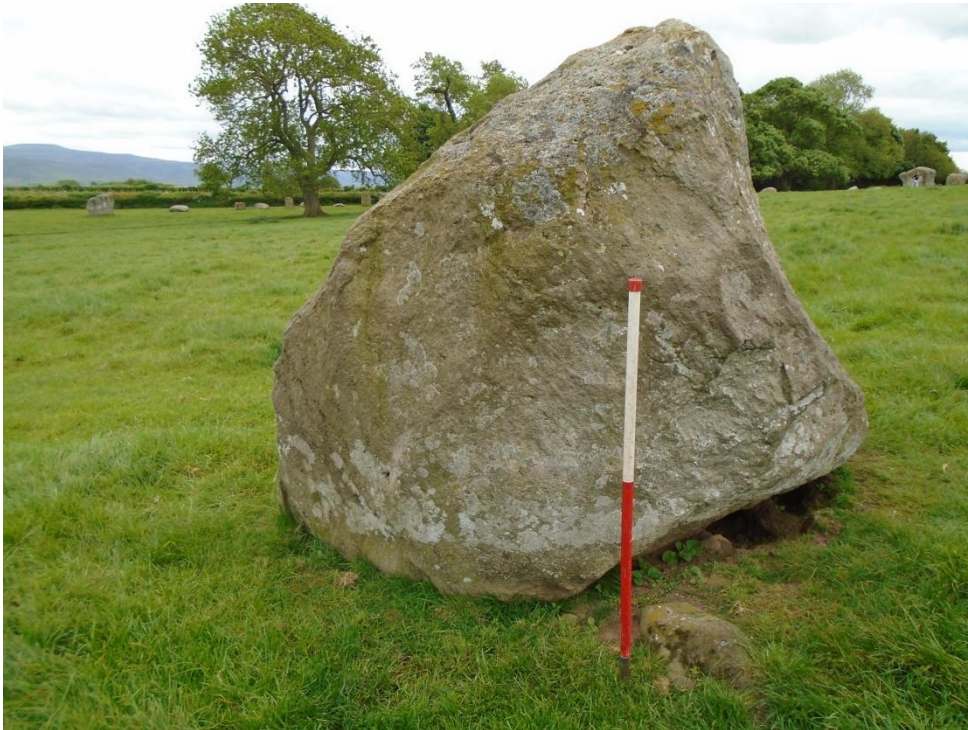
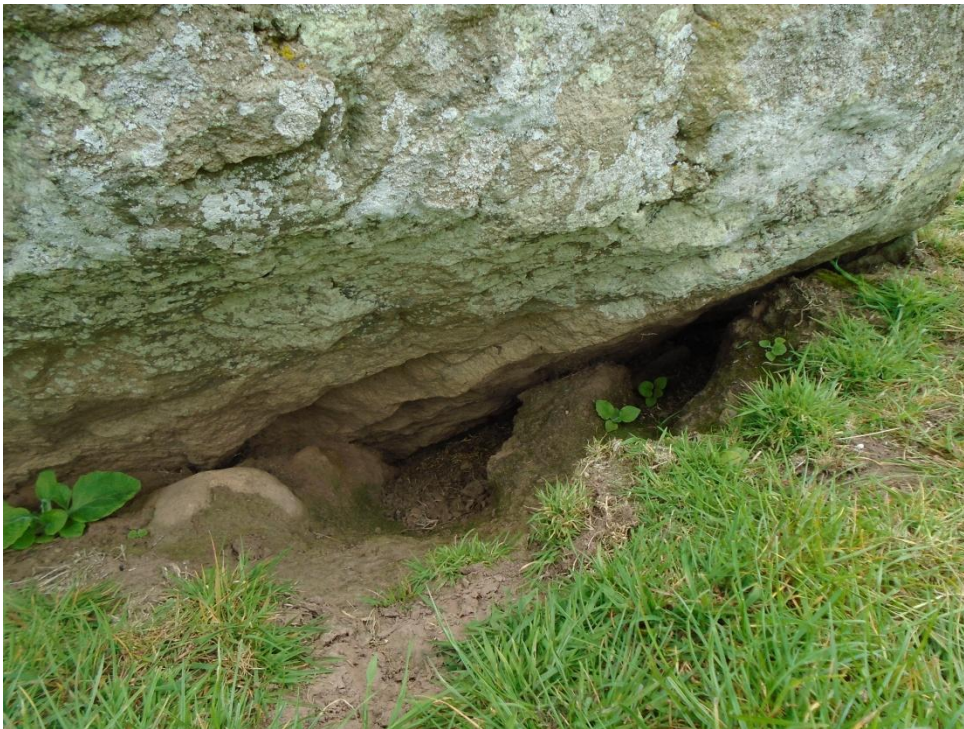
### **Stone 15**

Stone 15 is a BVG boulder that still stands to a height of 178cm. Its maximum circumference (parallel to the ground surface) is 572cm. Burrowing beneath it has exposed packing stones. Given its rather squat shape, the extent to which it may be set in the ground rather than simply sitting on the old ground surface is unclear. It is perhaps unlikely to topple, but the extent of burrowing beneath it is clearly disturbing archaeological deposits and must be stopped.

*Top: General view from the NW showing burrowing at base of stone.*

*Bottom: Close-up showing small stones which are presumably packing stones, exposed through rabbit burrowing.*

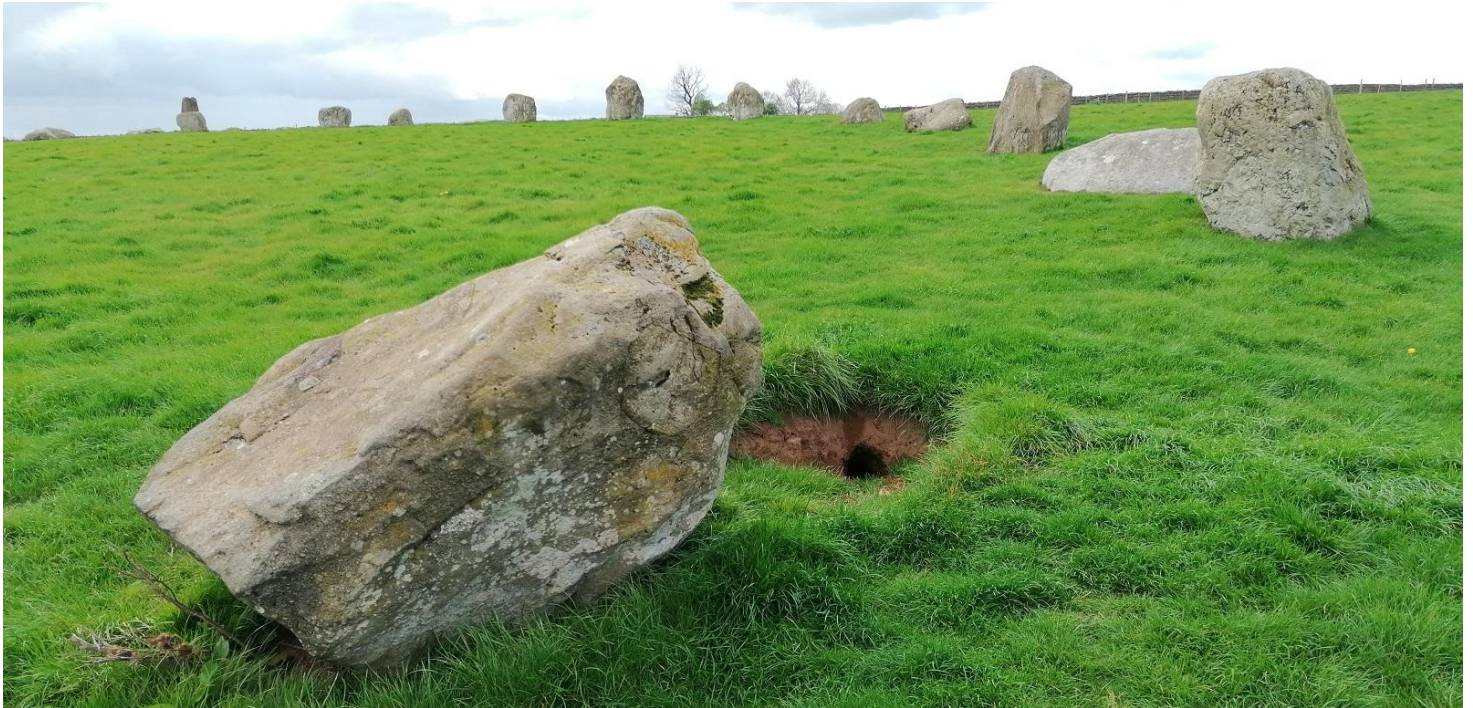
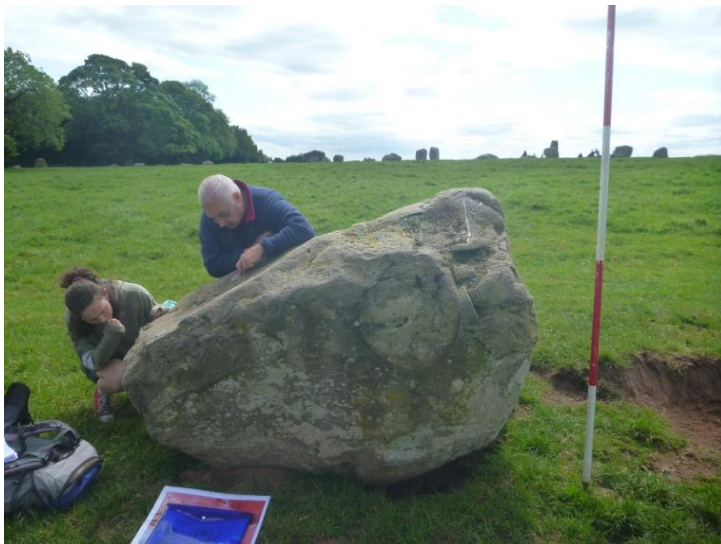
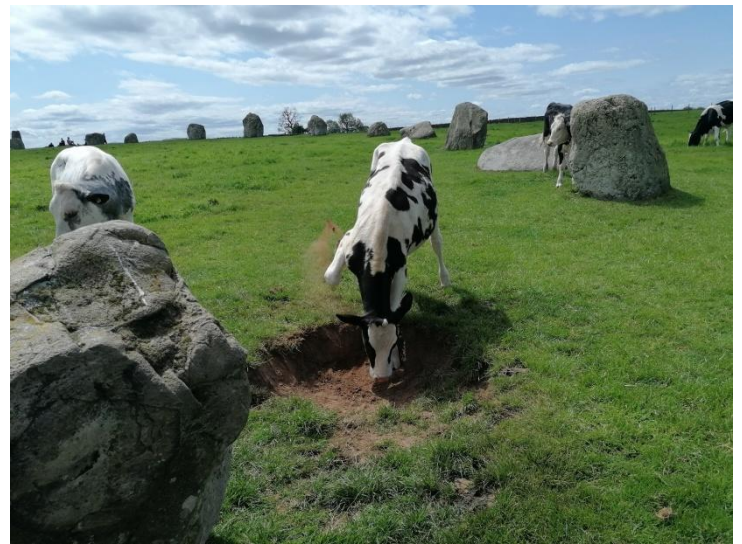
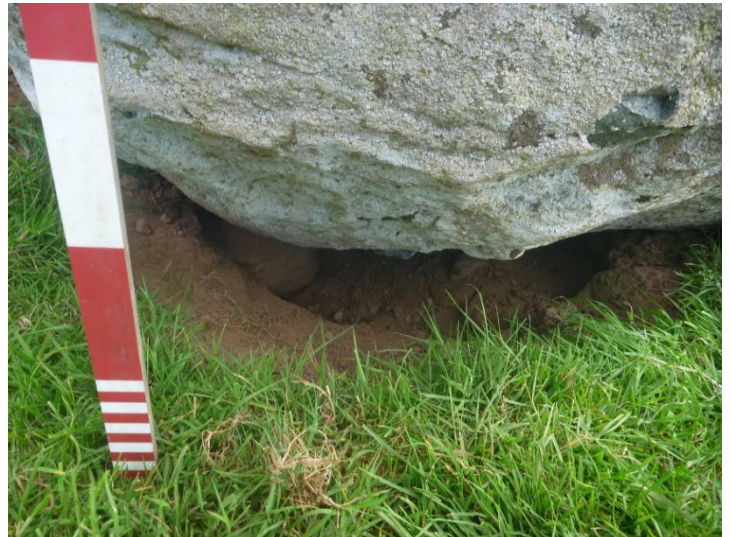
### **Stone 18**

Stone 18 is a fallen BVG boulder measuring 183 x 123cm, with a height above the turf of 130cm. It occupies an important position within the circle, being the eastern inner portal of the circle's supposed north-west entrance. Excavations around the opposite side of this entrance in 2015 demonstrated the presence and fragility of important archaeological features and deposits here. There is extensive burrowing around and beneath the stone, linked to a large hollow to the west. Old photos show a burrow within this hollow, which may extend for some distance underground. During the recent survey, cattle were observed standing within this hollow and one beast seemed to enjoy kicking soil out of it (see photo). A photo taken in May 2022 shows an eroded hollow to the east of the stone partly backfilled, into which someone had seemingly tried to plant a tree; this is no longer present. The area around Stone 18 is a crucial part of the monument, probably containing evidence relating to the relationship between the stone circle and the adjacent enclosure. Conservation work should take place here as a matter of urgency.

*Top: General view from the E taken in May 2022, showing burrow within erosion scar, and apparent recent attempt to plant a tree at the E end of the stone.*

*Centre left: General view from the N, showing burrowing beneath the stone.*

*Centre right: Proof that it isn't just rabbits that are responsible for damage here!*

*Right: Close up of burrowing beneath the stone, showing apparent packing stones.*

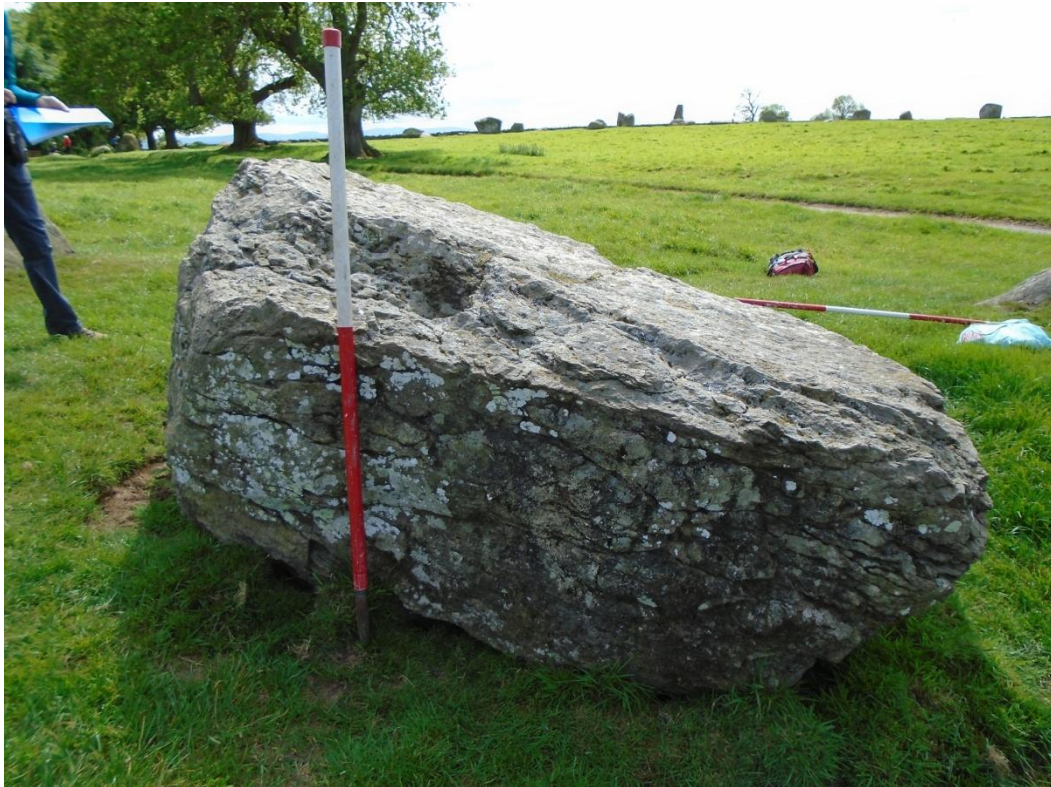
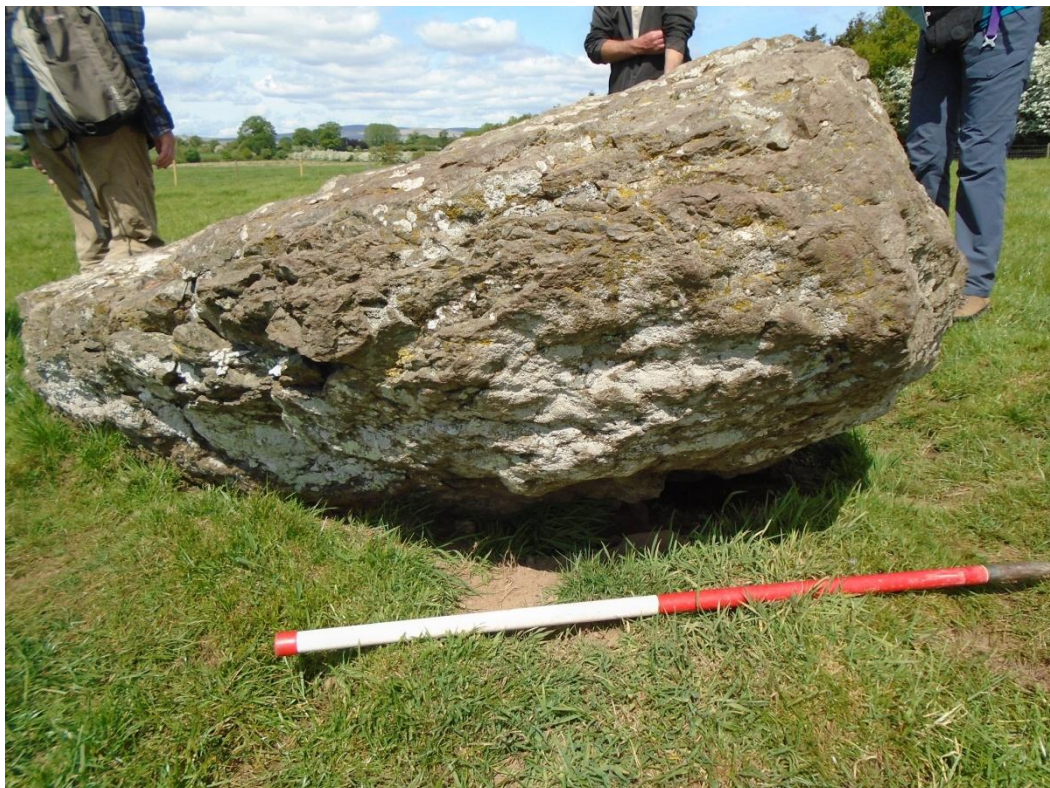
**Stone 34**

Stone 34 is a BVG boulder of an unusual type, not noted elsewhere within the circle. It measures 285 x 195cm, with a height above the turf of 184cm. It looks as though it must once have been standing, and apparent packing stones are visible in the large hollow beneath it which appears to have been dug out from several different directions.

*Two views showing burrowing beneath the stone. Top: from the NE. Bottom: from the SW.*

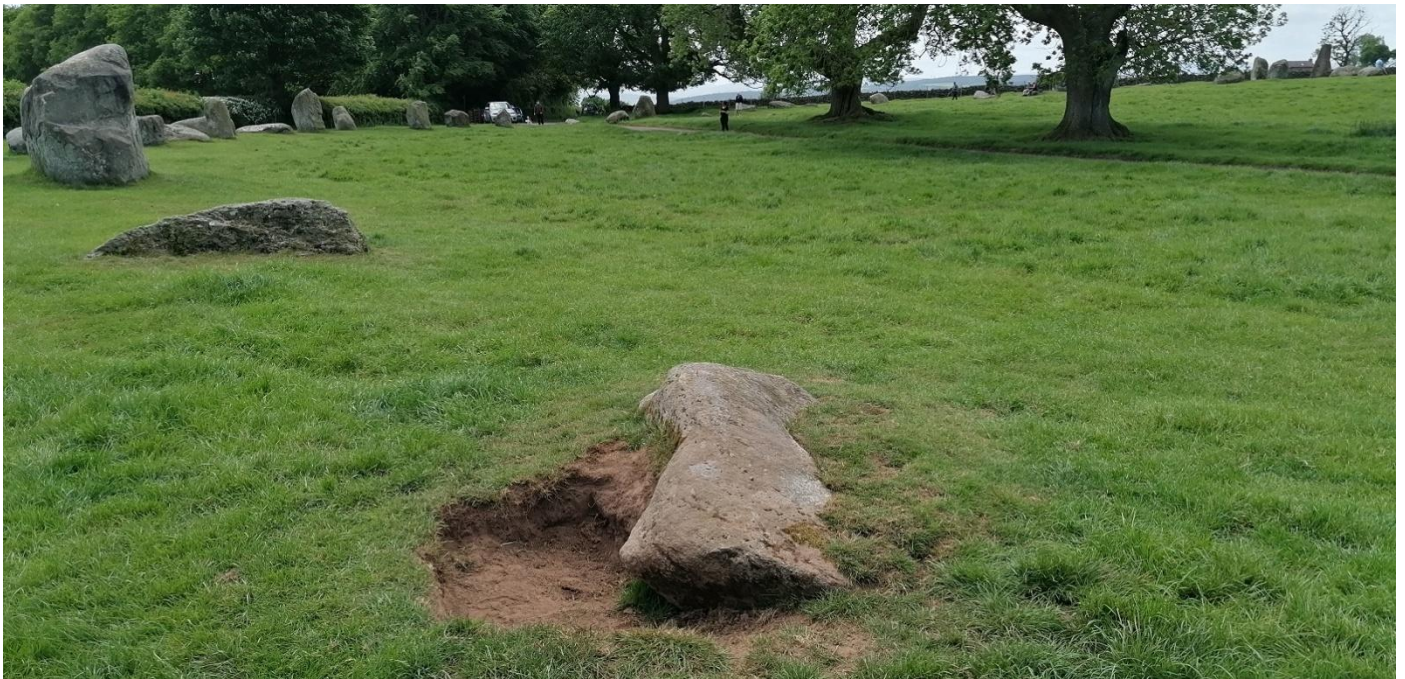
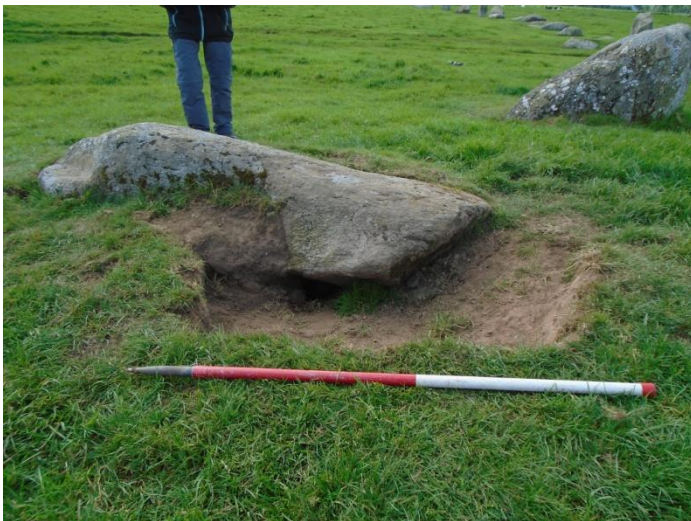
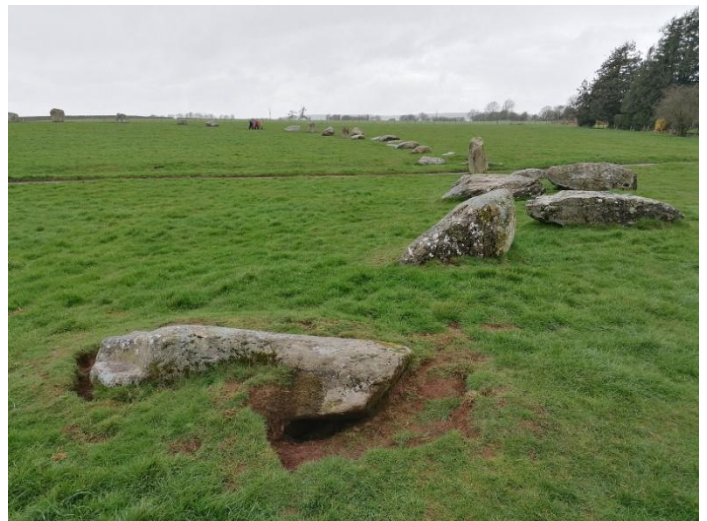
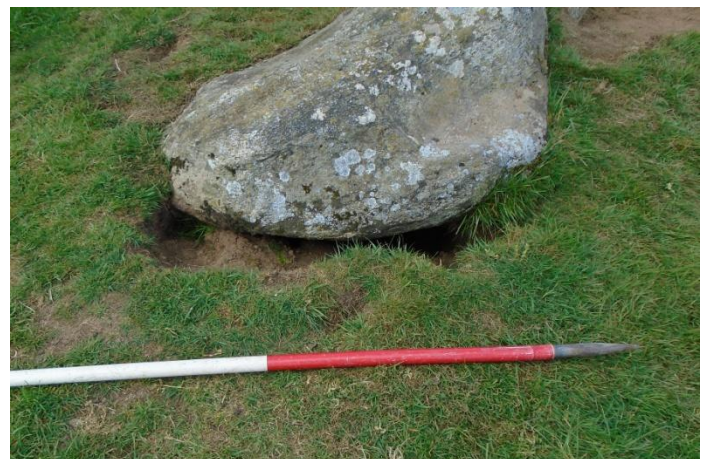
### **Stone 38**

Stone 38 is one of four granite boulders within the circle. The source of these has yet to be determined, but they are thought to be from either south-west Scotland or the Lake District. The 2025 excavations demonstrated that the size and shape of partly-buried Daughters cannot always be discerned from surface evidence, as they can extend a long way beneath the turf, but as currently exposed Stone 38 measures 213 x 70cm, and extends just 40cm above the turf. This makes it potentially one of the smallest of Long Meg's Daughters. The damage around it is severe, especially around and beneath its north-east angle; although not directly observed during the survey, this may be partly due to digging by cattle as with Stone 18 (as noted above). Whether or not the small number of granite Daughters at Long Meg were treated differently from their much more numerous BVG and Threlkeld Microgranite sisters cannot be known without excavation; relevant evidence may lie within the ground so it is absolutely essential that the damage here is arrested as soon as possible.

*Top: From the N, showing extensive erosion, taken in April 2023.*

*Centre left: From the E.*

*Centre right: From the E, showing erosion at E and W ends of stone. Taken in April 2023.*

*Right: From the W, showing burrowing beneath stone.*

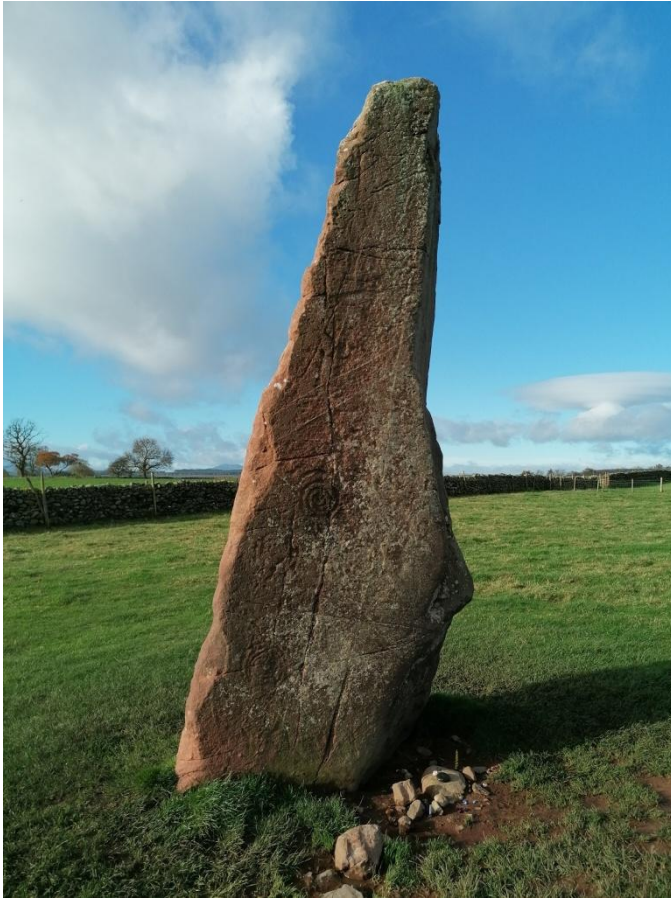
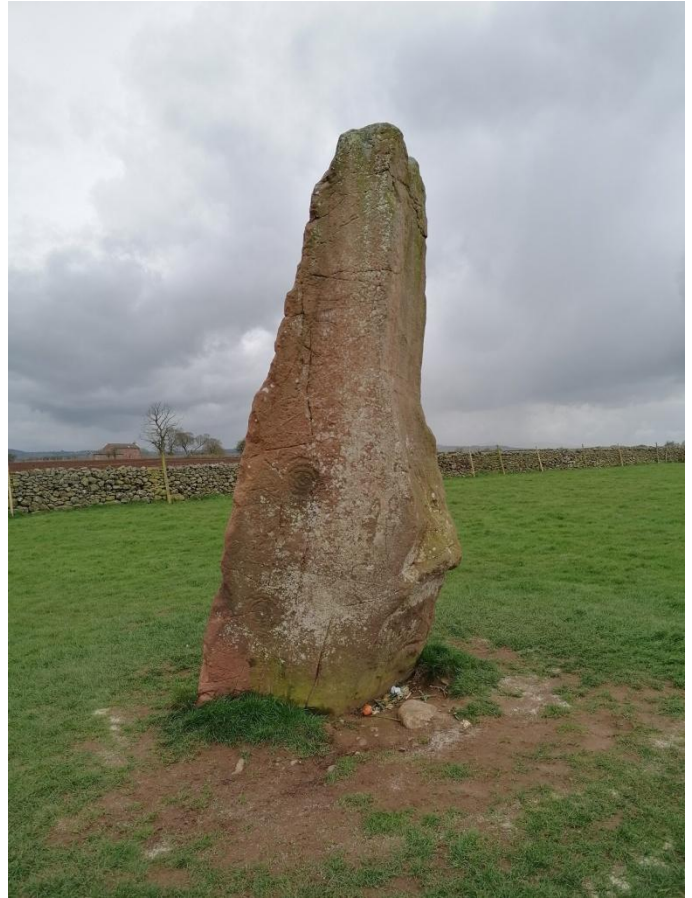
### ***Long Meg (Stone 1)***

Long Meg is a red sandstone monolith standing 3.8m above the turf, to the south-west of the circle. Unlike her Daughters, she is of very local origin, having apparently been sourced from nearby Penrith Sandstone river cliffs above the east bank of the Eden. The turf around Long Meg, especially to the N and E, is often worn away by visitors, exposing bare soil. In wet conditions this can become very muddy. However, this has been the case for decades, and no serious damage seems to be occurring.

*Views taken in October 2022 (left) and April 2023 (right), showing seasonal variation in grass cover. Sometimes, in wet conditions, the bare ground around Long Meg can be very muddy, but this has been the case for decades and is not considered to be a serious problem. Erosion here is probably due mostly to human visitors. Ritual offerings of various types are always present beneath Long Meg's north face.*

Should excavations along these lines be undertaken, the excavated areas should be carefully reprofiled upon completion of work so that within just a few weeks there should be no sign on the ground surface that they ever took place. In some cases, for example around Long Meg, thought could perhaps be given to introducing some kind of matting that would protect the surface from erosion and prevent further burrowing, while enabling the grass to grow through it and appearing invisible at the surface; various such products are available.
